Full length article**DAMMING HUNZA RIVER BY MASSIVE ATTABAD LANDSLIDE, STORY OF A RISK MANAGEMENT INITIATIVE FROM HUNZA, PAKISTAN**D. Karim¹, *, I. Karim¹, S. Daveel¹, A. Khan²

1 Department of Emergency Management, Aga Khan Agency for Habitat, Gilgit, Pakistan

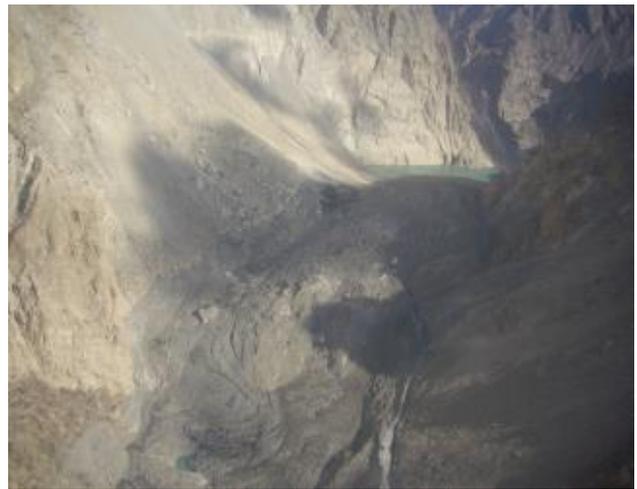
Figure 3: A NE aerial view of the Attabad landslide Source: FOCUS Pakistan, it triggered from the left side and blocked the narrow gorge of Hunza River and KKH. The debris material traveled 800m upstream and 1200m downstream while the length of the actual blockage was almost 950m. Totally the spread of the landslide debris was approximately 3km. The downstream surges damaged 8 houses in which 19 deaths occurred. Lacustrine deposits clay and silt

material spread at the upper surface of the landslide mass and it was squeezed out from the riverbed.

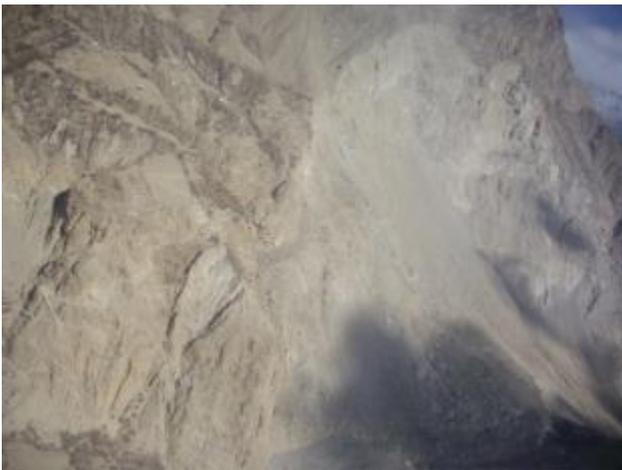
Figure 4: An aerial View of Attabad landslide, Source: FOCUS Pakistan, according to the interpretation of the features developed after the landslide, the landslide event occurred in 3 stages. First the central eastern portion came down as result the left portion came down due to dragging force and at the third stage; upper rock ridge came as observed at the top of the clay deposits above the debris mass. Minor time difference anticipated between the 1st and 2nd

portion which the 3rd phase came after the settlement of the whole debris mass.

Rock fall events started two days earlier of the landslide disaster and it continued till the event. According to one of the eye witnessed who was at Attabad village, said that a crack started from eastern end and moved towards NW side and crack started to open from western side and connected with the eastern crack fumes came out with the opening of the crack. At the same time multiple cracks developed in the whole landslide mass. The slopes slipped down 100ft cracking sounds were heard and the rock mass stopped for a while and then moved down at once and hit the river terrace. The river terrace material composed of cobbles, pebbles, clay and silt were squeezed and the whole river terrace material spread at over the whole debris material which was unique thing.

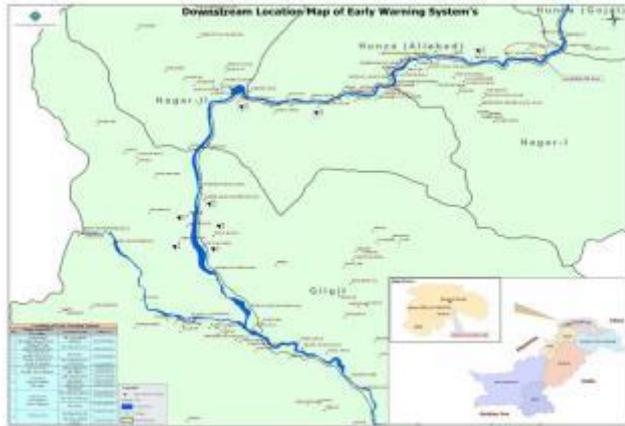
Figure 9: Map showing the locations of the Early warning system installed from Attabad to Gilgit.

The early warning systems were installed at 12 vulnerable locations starting from Salmanabad to Danyore. EWS was based on cellular Telenor sim, SMS will be sending to the sim and all the systems will be triggered at once giving alarm singles. In case of any emergency situation at the Attabad DC Hunza would be informed and he was the final authority to give orders for the trigger of the EWS.
